SERVICE NOTE

PRODUCT AFFECTED	ASSEMBLIES AFFECTED	DRAWINGS AFFECTED
OB-Xa serial numbers 810602 and before	Lower Control Board

OBERHEIM ELECTRONICS, INC.
ENGINEERING CHANGE ORDER

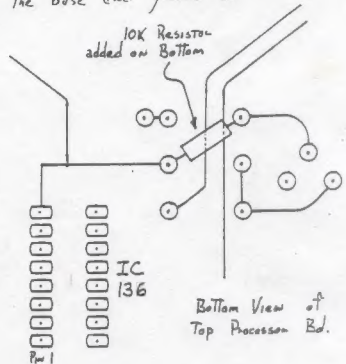
A 10K Resistor is added between the base and ground of the Power Detect Transistor.

Prevents false operation of Power-Up (PUP) Circuitry

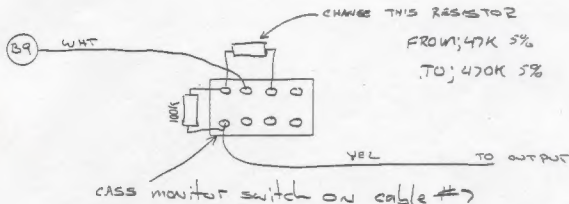
SHEET 4 OF 4
LOWER CONTROL BOARD

TO LOWER THE VOLUME IN THE "LOW" position of the
cassette monitor switch

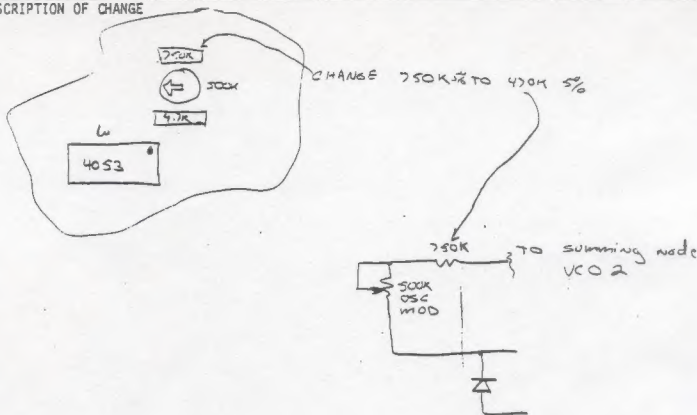
1520
VOICE CARD

REASON FOR CHANGE TO CENTER OSC MOD TRIMMER, THIS giving a more usable range.

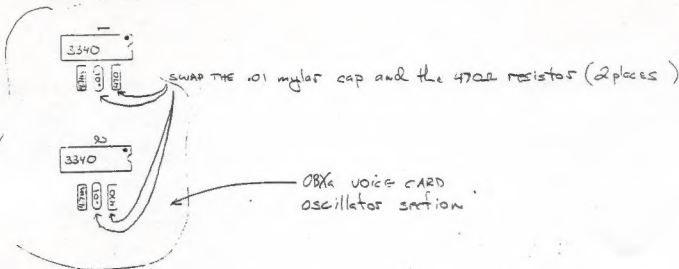
TO ELIMINATE the possibility of the oscillators phase coupling each-other.

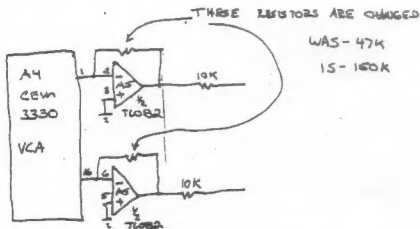
TO INCREASE THE GAIN OF THE OUTPUT VCA CIRCUIT.

Change 47K 5% resistor to 150K 5%, upper and lower mother boards; 2 places each.

The resistors are located near IC 5 (TWOB2) on both mother boards.

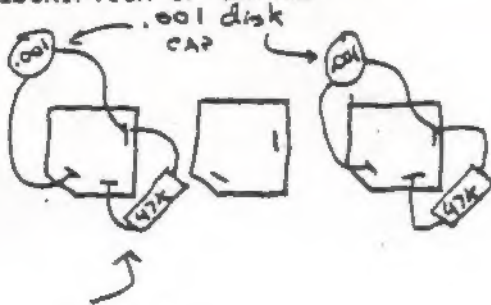
REASON FOR CHANGE TO ELIMINATE HIGH FREQUENCY NOISE IN OUTPUT UCA CIRCUIT.

INSTALL TWO .001 disk capacititors from
tip to ground on each output jack
(left and right)

- KEEP LEADS SHORT AS POSSIBLE

- BE SURE TIP OF PLUG CLEARS CAPACITOR
WHEN INSERTED INTO JACK.

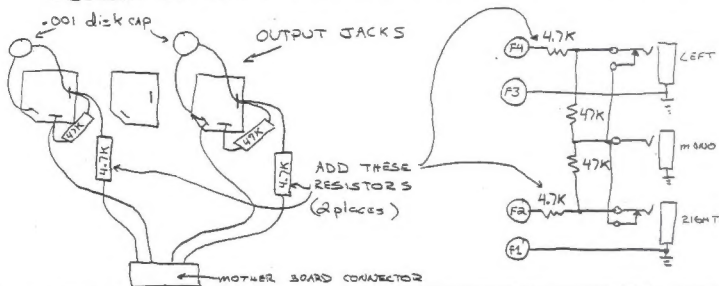
TO ELIMINATE THE POSSIBILITY OF 'BLOWING' THE P CHANNEL FET IN THE OUTPUT CIRCUIT, WHEN PLUGGING A CABLE INTO THE OUTPUT JACKS

ADD 4.7K 5% RESISTOR IN SERIES WITH EACH OUTPUT
(LEFT AND RIGHT)

- CUT POSITIVE LEAD OF EACH OUTPUT CABLE AT THE JACK TIP
- SOLDER ONE END OF THE RESISTOR TO THE CUT LEAD.
- SOLDER THE OTHER END TO THE TIP OF THE OUTPUT JACK.

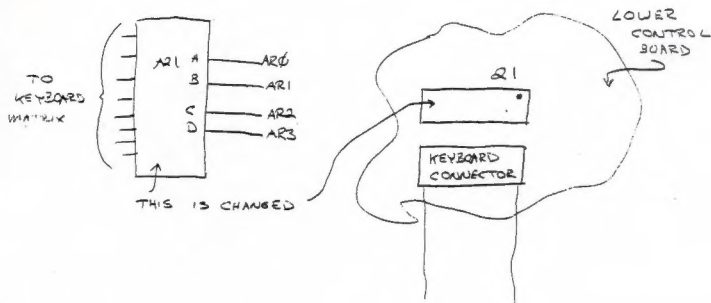
ELIMINATE IMPROPER DECODING OF KEYBOARD WHEN PLAYING "TIGHT" CHORDS

REPLACE 74C42 AT LOCATION A21 TO 74LS42.

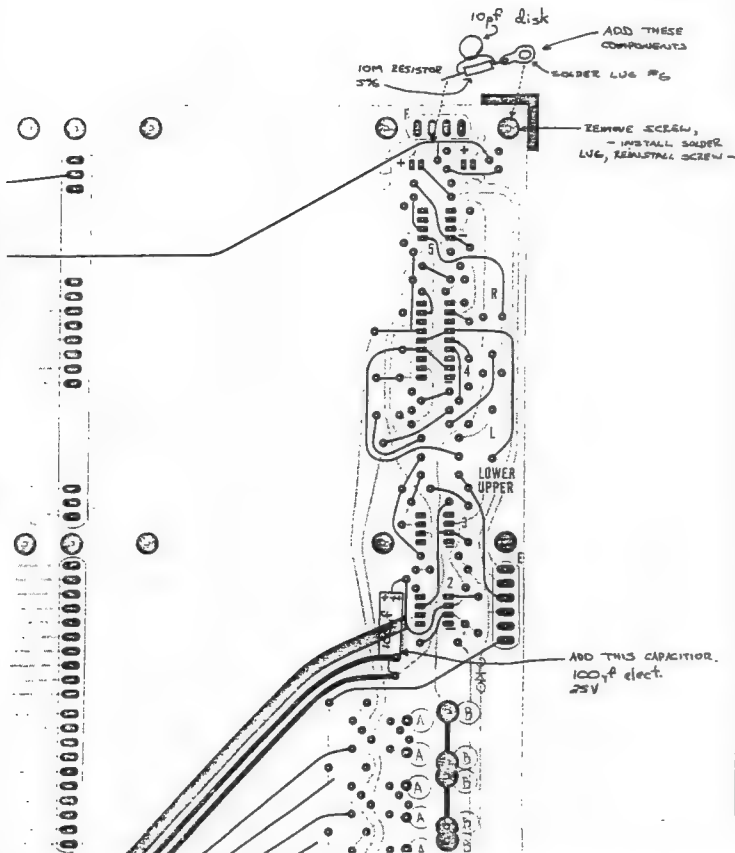
OBXa TOP MOTHER BOARD

TO DECREASE NOISE IN OUTPUT VCA CIRCUIT.

1-INSTALL 10pf disk cap. and 10 M 5% resistor from upper tray ground to PUP line, near J177 FET's. (UPPER MOTHER ONLY)

2-INSTALL 100pf elect. cap from -15V supply to ground. (BOTH MOTHER BOARDS)

3-INSTALL 100uf ELEC. CAP FROM +15 V SUPPLY TO GND. (BOTH MOTHER BOARDS)

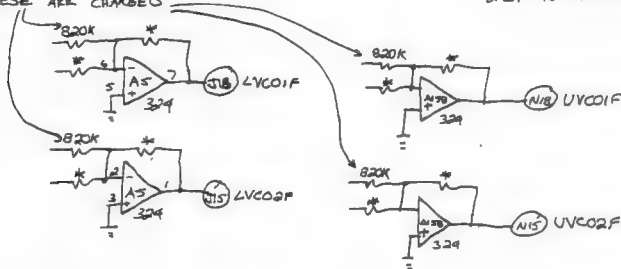
TO MATCH THE LFO GAIN BETWEEN VCO'S.

REPLACE 4 820K 5% resistors to 806K 1%. 2EA upper control.
2EA lower control.
THESE ARE CHANGED

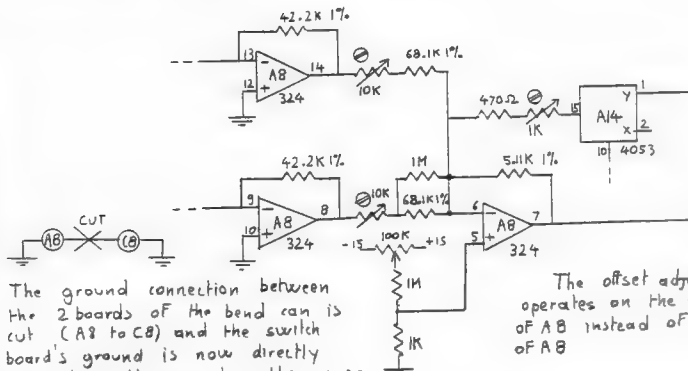
OB-XA MODULATION PANEL
DRAWING NO 1521

Improve the offset adjustments.

The offset adjustment operates on the + node of A8 instead of - node of A8

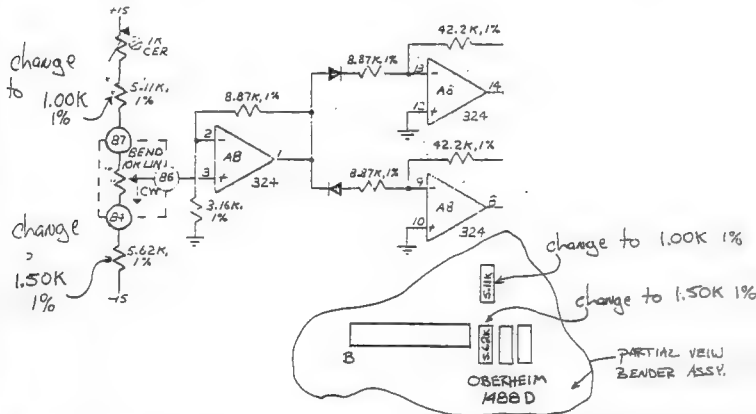
To increase the range of the "center lever" trimmer, (1K cer)

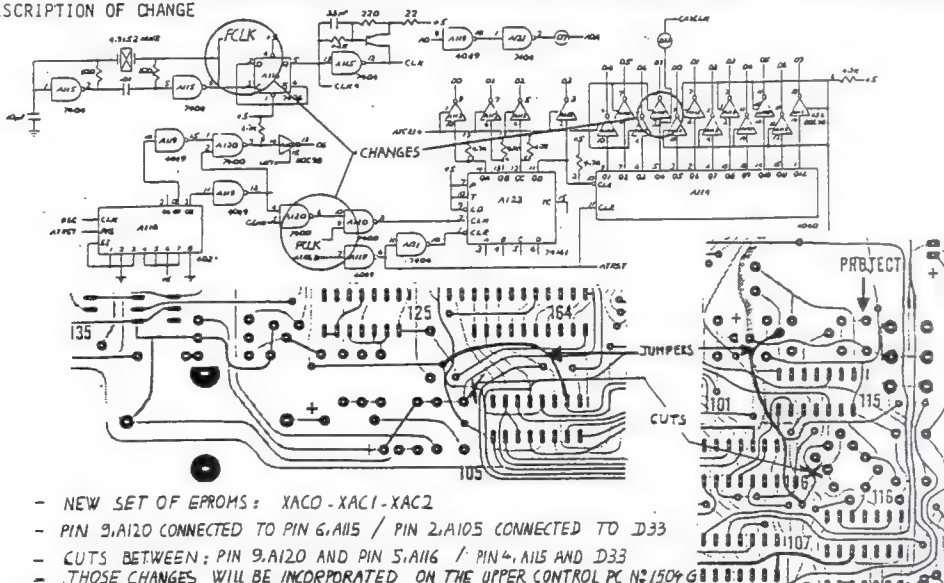
UPPER CONTROL BOARD SHEET 1
N° 1517

IMPROVE AUTO TUNE

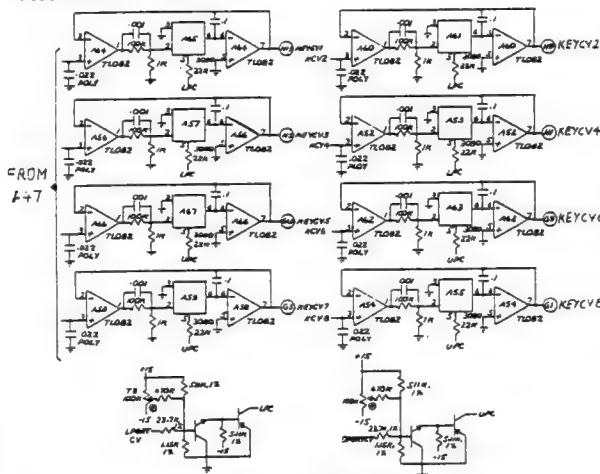
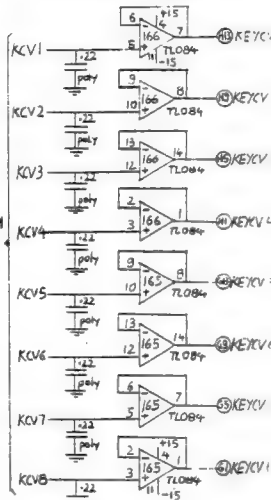
OB-XA LOWER CONTROL 1516 SHEET 3

- Improve the portamento speed matching between different voices
- Simplify the analog circuitry

- NEW SET OF EPROMS (2x2732) XADO XADI
- THE PORTAMENTO IS NOW IMPLEMENTED BY THE SOFTWARE

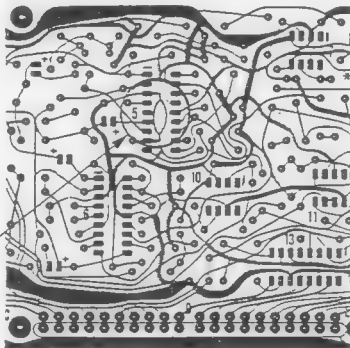
VOICE CARD N° 1520

— REMOVE OSCILLATION

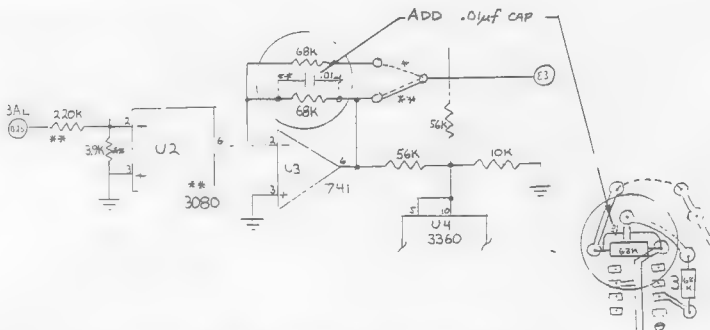
To eliminate dac stepping noise at the output from the balance control.

- .01µf capacitor added in parallel to 68K resistor
in U3 feedback network on lower Mother Board (top side)

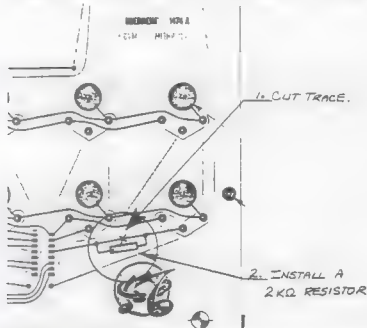
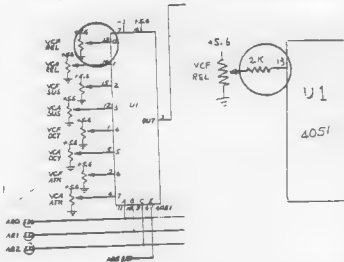
AN OPTIONAL HARDWARE FIX FOR XA'S AND 08-X'S THAT HAVE OLD SOFTWARE (2016 EPROMS), CONTAINING AN ERROR WHICH CAUSES NOISE TO BE HEARD WHEN THE VCO PULSEWIDTH CONTROL IS FULLY COUNTER-CLOCKWISE, AND THE VCF RELEASE CONTROL IS FULLY CLOCKWISE.

MAKE ONE CUT ON THE TRACE COMING FROM THE SWINGER OF THE VCF RELEASE RT, AND INSTALL A 2 K Ω RESISTOR ACROSS THE CUT. THIS REDUCES CURRENT THROUGH THAT TRACE. NOTE: DO THIS TO UNITS CONTAINING XA-F β (NOT TO XA-FA) AND TO UNITS CONTAINING THE XA-C β , XA-C1, XA-C2 SERIES EPROMS OR BELOW ONLY. UNITS WITH EPROMS XA-G β , XA-G1 AND ABOVE, DO NOT NEED THIS FIX.

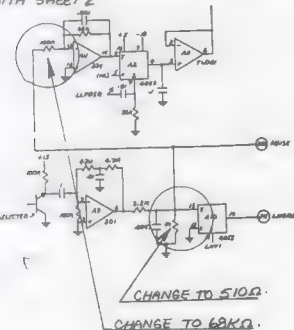
UPPER CONTROL BD:
17A SHEET 2

TO REDUCE THE VOLUME OF THE NOISE FUNCTION

DESCRIPTION OF CHANGE - CHANGE 3 RESISTORS

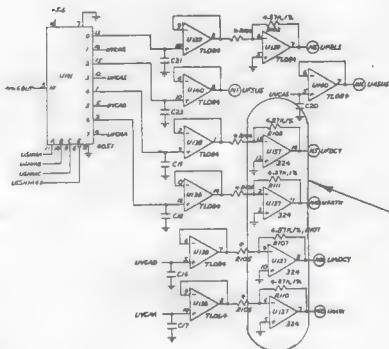
TO MATCH FILTER ENVELOPE CHARACTERISTICS BETWEEN TOP AND BOTTOM TRAYS.

CHANGE U137 FROM AN LM324 TO A TL084.

CHANGE TO TLO84.

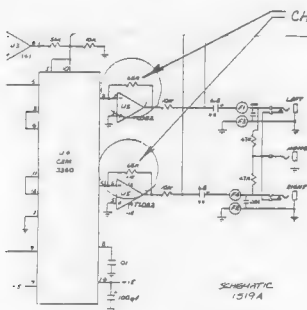
TO INCREASE GAIN OF OUTPUT.

1. CHANGE A TOTAL OF 4 RESISTORS PER 08-XA UNIT
 FROM 68K TO 120K.

CHANGE TO 120K ON TWO MOTHER BOARDS.

2. CHANGE RESISTOR ON CASSETTE
 MONITOR SWITCH (REAR PANEL) TO
 68KΩ. THIS RAISES CASSETTE
 MONITOR VOLUME, KEEPING RATIO
 OF THE VOLUMES OF SYNTHESIZER
 OUTPUT AND CASSETTE MONITOR
 CONSISTANT.

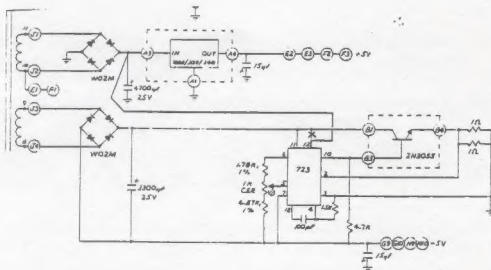
Allow for operation down to 90 VAE input.

Cut lead going to pin 12 of the -5
723. regulator & run that pin to the
+ lead of the +5 filter cap.

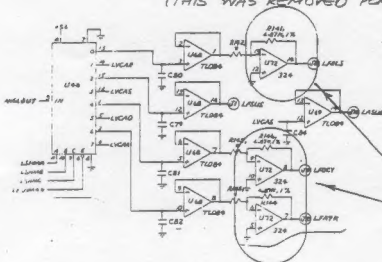
TO ELIMINATE FILTER ENVELOPE NON-MATCHING PROBLEMS
CAUSED BY SENSITIVITY OF 324 TO NOISE.
(SEE ECO #135)

1. CHANGE UT2 FROM AN LM324 (313022) TO A TL084 (313024).
 2. ADD 1 EA: 219902 14 PIN I.C. SOCKET AT LOCATION UT2.**
- (THIS WAS REMOVED FOR ECO #137)
